INSPECTION REPORT

**123 Main St
Hometown, MN
55555**

**Richard Katz
Katz Family Home Inspection, LLC
9522391053
katzfamhi@gmail.com**

2/24/2022

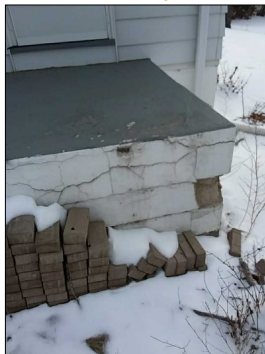
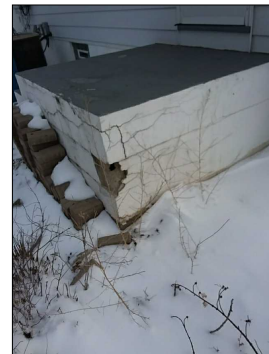
4. Condition

- Heavy cracking and deterioration noted on the rear steps. This will not improve over time. Repairs should be made to lessen further deterioration.
- A guard and hand rail should be added to the rear stairs for safety and convenience reasons. This may be required by mortgage and insurance companies.

Deterioration on the back stairs.

Items Needing Attention		
Grounds		
Page 8 Item: 4	Condition	<ul style="list-style-type: none">• Heavy cracking and deterioration noted on the rear steps. This will not improve over time. Repairs should be made to lessen further deterioration.• A guard and hand rail should be added to the rear stairs for safety and convenience reasons. This may be required by mortgage and insurance companies.
Garage		
Page 14 Item: 2	Garage Opener Status	<ul style="list-style-type: none">• The garage door opener was not operational at the time of the inspection.
Roof		
Page 18 Item: 4	Gutter	<ul style="list-style-type: none">• Downspouts should extend a minimum of 5 feet from the foundation.
AC		
Page 21 Item: 2	Enclosure	<ul style="list-style-type: none">• The exterior compressor fins are dirty and need to be cleaned. Keeping the fins clean will improve the AC units overall performance. This process can be done by a service or as a relatively easy DIY project.

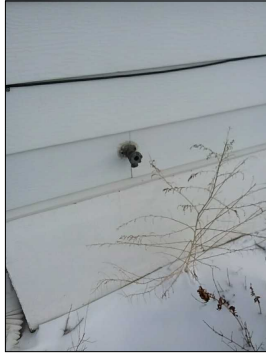
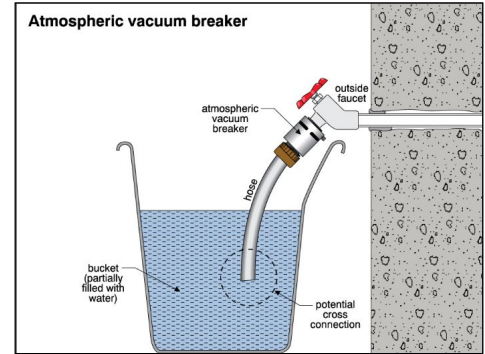
5. Exterior Faucet Condition

- Hose bibs are shut off for the winter season and were not tested during the inspection. If the location of the hose bibs shutoff is not obvious the seller should be asked to point it out.
- Hose bib(s) are not equipped with an anti-siphon device. This could compromise the homes drinking water.

Page 9 Item: 5	Exterior Faucet Condition	• Hose bib(s) are not equipped with an anti-siphon device. This could compromise the homes drinking water.
----------------	---------------------------	--

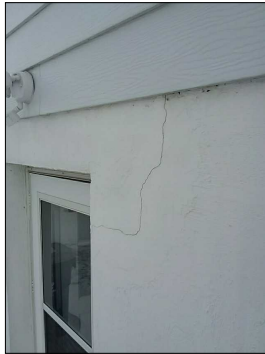
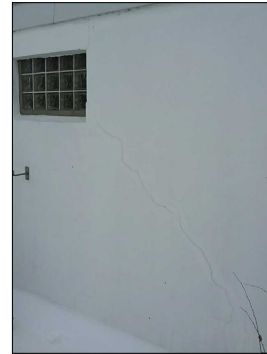
4. Exterior Foundation

- Foundation Material / Type.Block
- Minor cracks were noted in the foundation walls. These cracks are either normal drying cracks (poured foundations) or joint cracks in concrete blocks. It is advisable to fill there cracks to minimize water intrusion and further growth. These cracks should be monitored. Improving the drainage around the foundation will also help to minimize stress and cracking.

Page 12 Item: 4	Exterior Foundation	• Minor cracks were noted in the foundation walls. These cracks are either normal drying cracks (poured foundations) or joint cracks in concrete blocks. It is advisable to fill there cracks to minimize water intrusion and further growth. These cracks should be monitored. Improving the drainage around the foundation will also help to minimize stress and cracking.
-----------------	---------------------	--

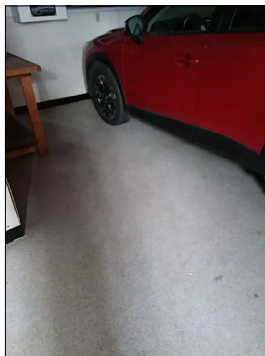
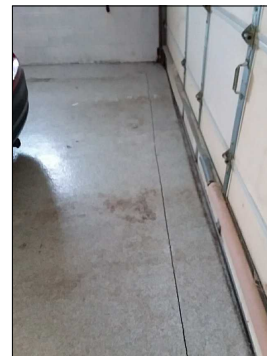
7. Floor Condition

- Large settling crack at the lip of the garage.

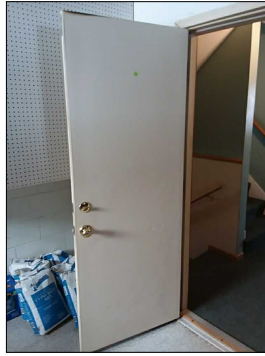
- There is no self-closing device on the door from the house leading to the garage. It is strongly recommended that one be installed in order to protect the residence against garage originated fires.

Page 15 Item: 9	Entry Fire Door	• There is no self-closing device on the door from the house leading to the garage. It is strongly recommended that one be installed in order to protect the residence against garage originated fires.
-----------------	-----------------	---

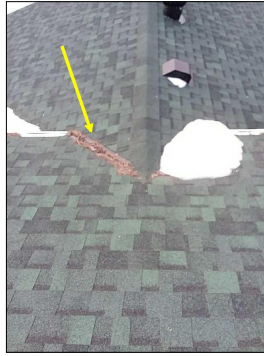
2. Flashing

Observations: There were no visible issue with any readily accessible sections of roof flashing., The **valley**s are covered with organic material. This should be removed. Additionally, the roof should be regularly assessed to make sure build up doesn't continue., Drip flashing was noted at the roof eaves and at rake boards.

The small lengths of **valley flashing** should be kept clear of debris.

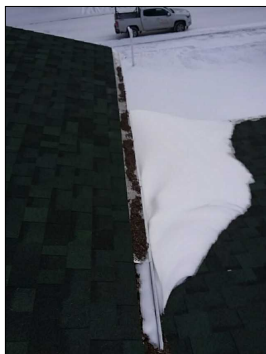
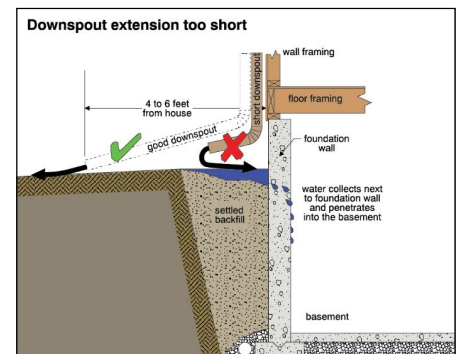
- Downspouts should extend a minimum of 5 feet from the foundation.

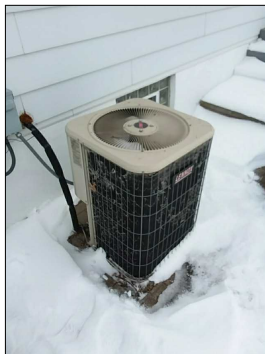
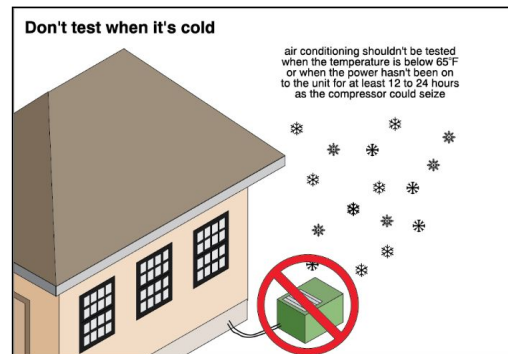
- Breaker size installed for this unit: 30 amps
- Refrigerant type: HCFC-22
- Units size: 2.0 Tons
- The installed circuit breaker is rated 10 amps greater than the manufacturer's recommendation. There is a possibility that, at the exterior service disconnect (small rectangular box located by the exterior condenser unit) is fused and, to this point, fused appropriately to handle any objectionable current. I was not able to access the disconnect at the time of the inspection. Knowing the age of the unit, I would just make sure that once this unit is replaced the breaker be sized appropriately for the new unit.

- The AC unit was not tested due to the exterior temperature. Operating an AC unit when the temperature has been below 60 degrees within the last 24 hours can damage the unit's compressor.

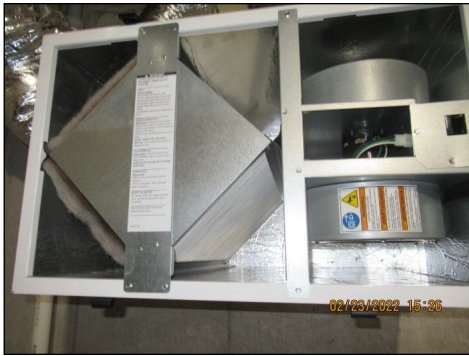
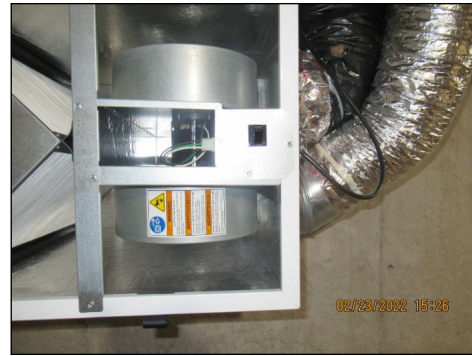
3. HRV Condition

- [The Heat recovery Unit was operating at the time of the inspection. No issues were noted other than the filters were a bit dirty. The homeowners can familiarize themselves with the operation and maintenance of this unit by downloading the users manual from the companies website.](#)

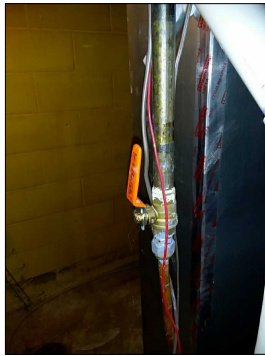
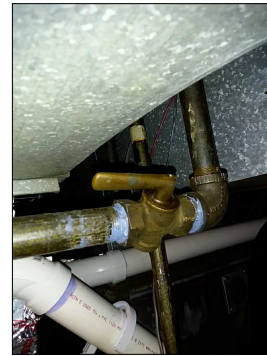
- Gas shut off valve was present and functional.
- Drip leg noted and properly installed.

Older brass gas valves like this should eventually be replaced.

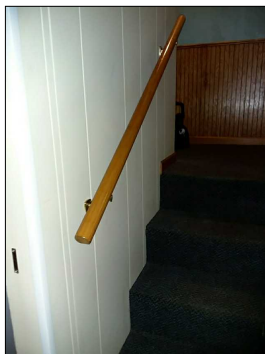
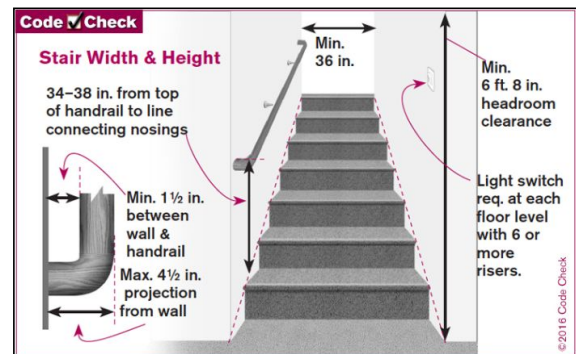
- Railing lacks the proper return to wall that is required by current building standards, repair recommended for enhanced safety to occupants.

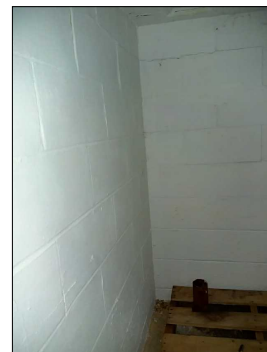
3. Walls

- No deficiencies were observed at the visible portions of the structural components of the basement walls other than some hairline cracks noted in the well room.

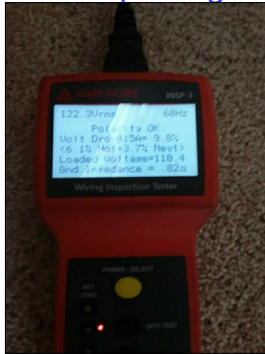
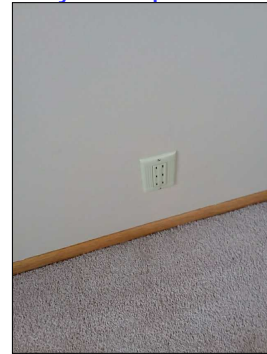
- All accessible receptacles were tested and found to be in working order.
- The home contained outdated, ungrounded 2-prong electrical receptacles. Although this condition may have been commonly considered safe or acceptable at the time the home was originally constructed, as general knowledge of safe building practices has improved with the passage of time, building standards have changed to reflect current understanding. Consider updating the existing condition to meet generally-accepted current standards.
