INSPECTION REPORT

**123 Main St
Hometown, MN
55555**

**Richard Katz
Katz Family Home Inspection, LLC
9522391053
katzfamhi@gmail.com**

2/24/2022

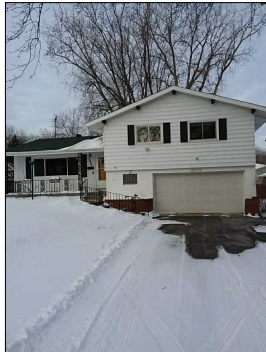
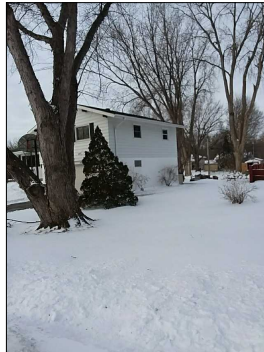
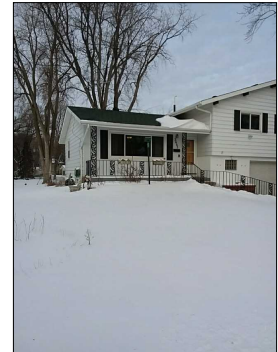
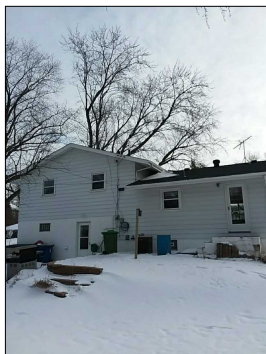
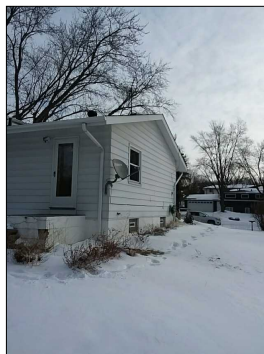
- From a distance all views of the home looked to be square, plumb, and true and did not give any obvious visual indications of any structural issues. See each specific section for more details.
- Front of the house, Rear of the house, Left Side of the house, Right Side of the house, Garage

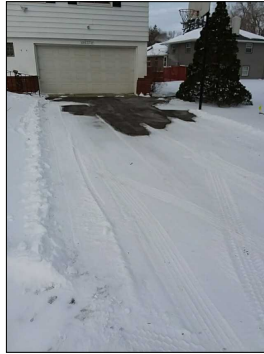
2. Driveway Condition

- The driveway is mostly or completely snow covered and was not visible for evaluation at the time of the inspection.

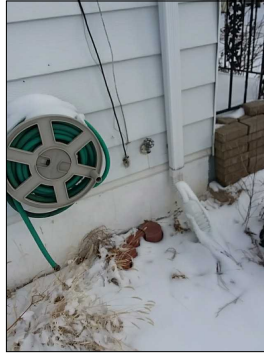
5. Exterior Faucet Condition

Page 9 Item: 5	Exterior Faucet Condition	• Hose bib(s) are not equipped with an anti-siphon device. This could compromise the homes drinking water.
----------------	---------------------------	--

- Hose bibs are shut off for the winter season and were not tested during the inspection. If the location of the hose bibs shutoff is not obvious the seller should be asked to point it out.
- Hose bib(s) are not equipped with an anti-siphon device. This could compromise the homes drinking water.

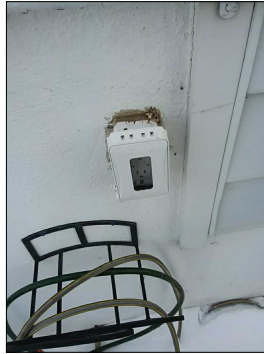
6. Exterior Outlets

- Receptacle cover would not open.

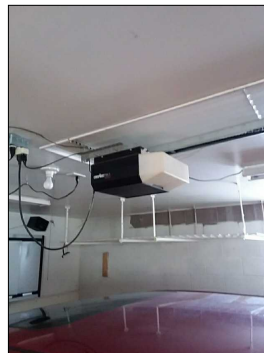
2. Garage Opener Status

- The garage door opener was not operational at the time of the inspection.

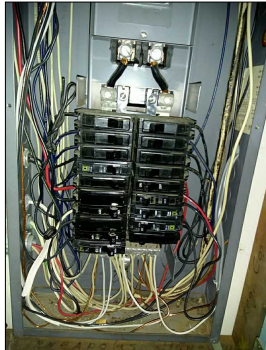
- A white wire on a double pole breaker should be remarked with black or red tape.
- The transformer for the doorbell is improperly double tapped on a breaker. This could be easily corrected.

This wire should be re-identified as black or red.

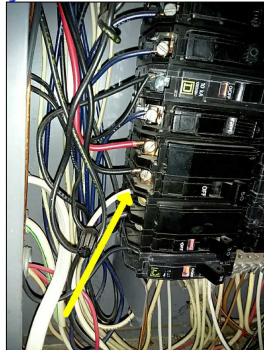
Double tapped doorbell transformer wire.

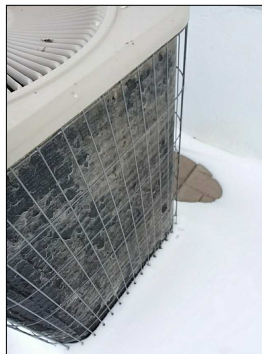
- The exterior compressor fins are dirty and need to be cleaned. Keeping the fins clean will improve the AC unit's overall performance. This process can be done by a service or as a relatively easy **DIY** project.

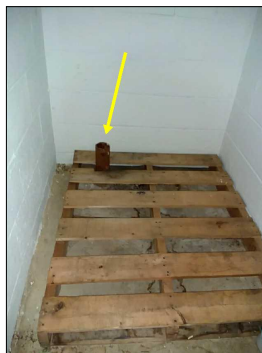
Well Head

- The well has obviously been abandoned. It is unclear if it has been capped to an acceptable level. Confirmation via a well disclosure should be gained.

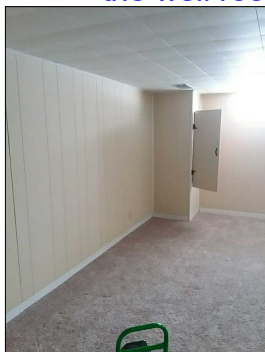
- No deficiencies were observed at the visible portions of the structural components of the basement walls other than some hairline cracks noted in the well room.

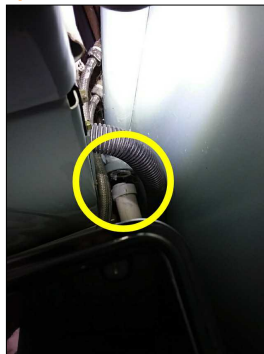
- Plumbing / DWV pipe. Wash basin drains to:
- The utility sinks trap arm pipe is broken at the connection to the drain pipe. This needs to be repaired.

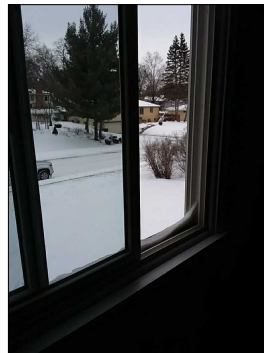
- All accessible windows operated properly at the time of the inspection.
- Missing screen.

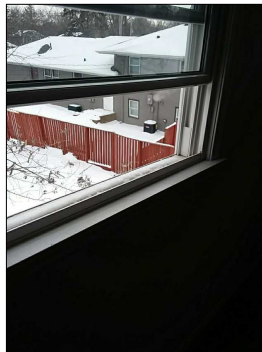
2. Window Condition

- All accessible windows operated properly at the time of the inspection.
- Missing screens.

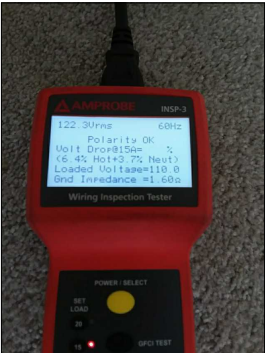
Observations:
• All accessible receptacles were tested and found to be in working order.

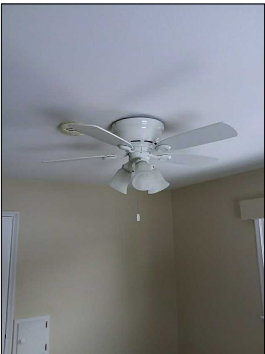
7. Ceiling Fans

Observations:
• Operated normally when tested at time of inspection.

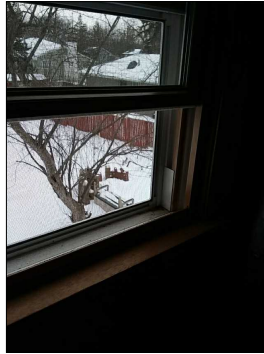
5. Window Condition

- All windows tested were functional and showed no issues.

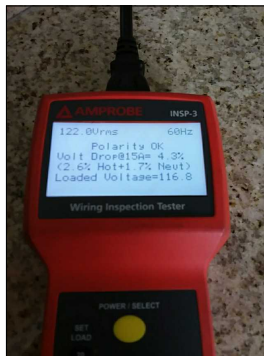
- The electrical receptacles were tested and found to be in good working order. GFCI outlet(s) were installed.

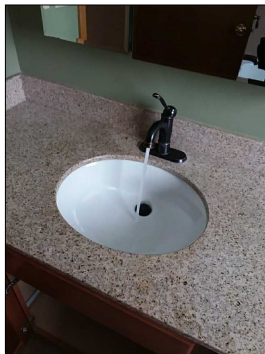
8. Plumbing

- Plumbing connections appear acceptable and no leaks were noted at the time of the inspection.

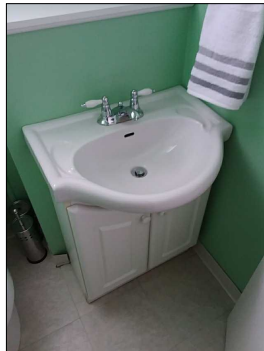
2. Vanity

- The vanity, cabinet, and sink were in good condition and no visible issues were noted.

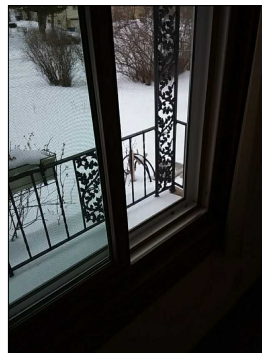
2. Window Condition

- All accessible windows were tested. No issues were seen.

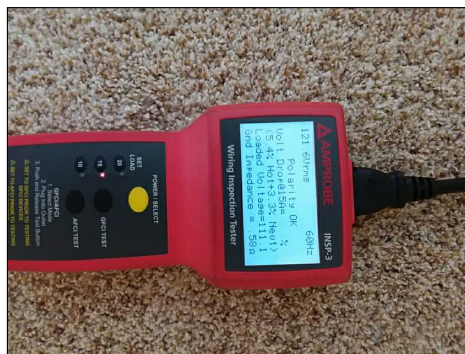
3. Electrical

- All accessible receptacles were tested and found to be in good working order.

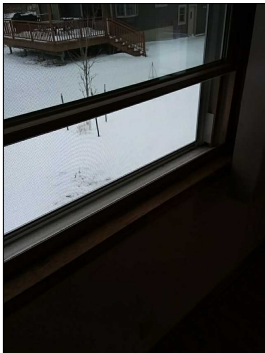
2. Window Condition

Materials: Vinyl or vinyl clad windows noted.
Observations:
• All accessible windows were tested and found to be in working order.

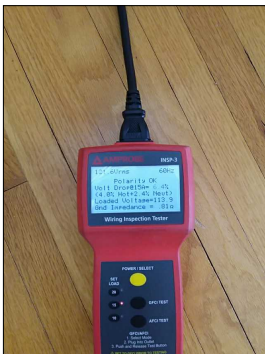
3. Electrical

Observations:
• All accessible receptacles were tested. No issues were found.

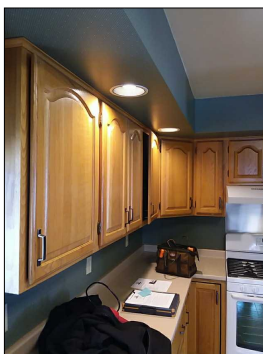
2. Cabinets

- Upper and base cabinets were in proper working order, properly affixed, and with only minor imperfections at the time of the inspection.

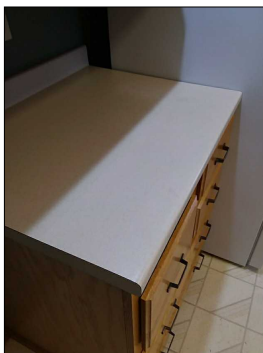
3. Counters

- Laminate counter tops noted.
- Counter tops were in proper condition at the time of the inspection.

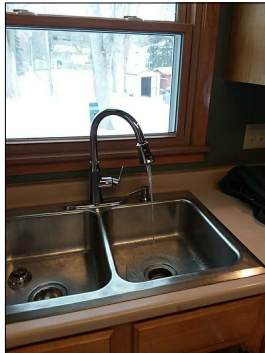
4. Plumbing

- Sink connects were proper and no leaks were noted.

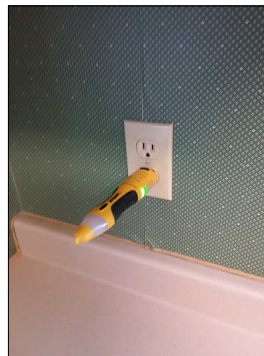
5. Electrical

- The majority of grounded receptacles , were tested and found to be wired correctly.

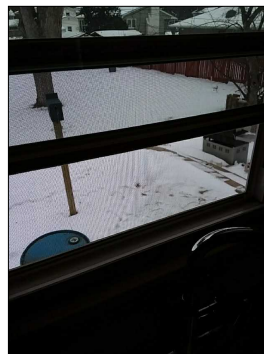
6. Window Condition

- No issues were observed on the windows that were operated at the time of the inspection.

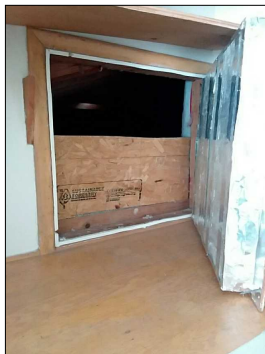
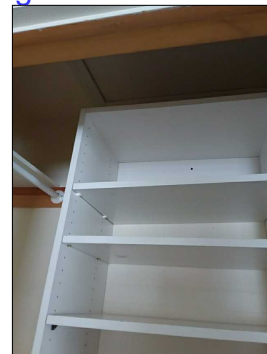
- Scuttle Hole located in: Bedroom closet. (Not accessible)
- The small area that shows roof framing, sheathing, etc was accessed by an access door / panel.
- Entering attics that are heavily insulated can cause damage to the insulation and attic framing. Attics with deep insulation cannot be safely inspected due to limited visibility of the framing members upon which the inspector must walk. In such cases, the attic is only partially accessed, thereby limiting the review of the attic area from the hatch area only. Inspectors will not crawl the attic area when they believe it is a danger to them or that they might damage the attic insulation or framing. This is a limited review of the attic area viewed from the hatch only.
- Limited visibility due to size of entry opening.

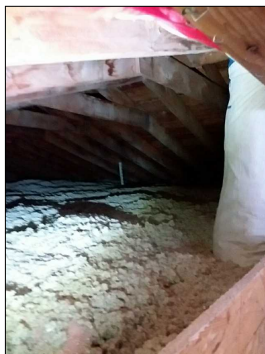
2. Structure

- Rafters noted
- Plywood sheathing noted
- No visible issues were noted in the attic space. Because of limited access not all areas were visible.

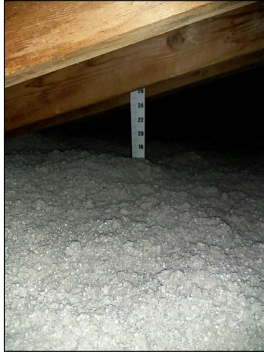
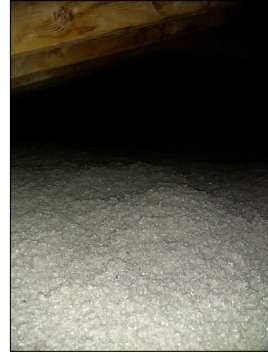
4. Insulation Condition

- Insulation appears to be properly installed at an adequate level.

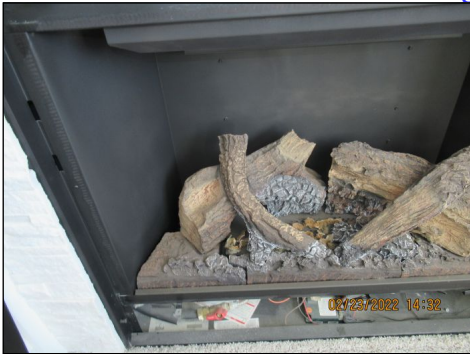
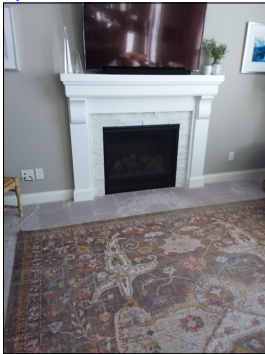
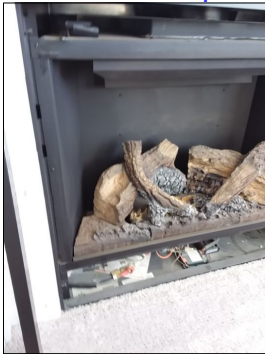
1. Condition

- No visible issues were noted with the fireplace(s), surround, glass front, refractory panels, or gas valves. A basic combustion gas test is done to check for gas leaks; no issues were observed at the time of the inspection.

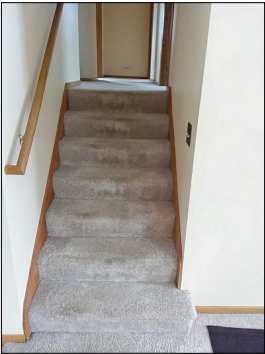
1. Stair Condition

- No visible issues were noted with the stairs.

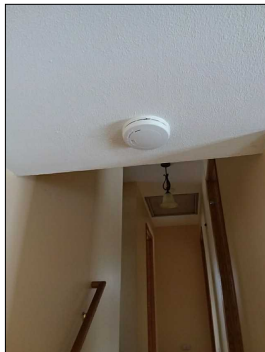
2. Condition

- A representative number of detectors were tested and found to be in good working condition.
- One or more of the installed detectors is a combo smoke and CO detector.
